Manhole Inspection Summary

Manhole # S19QQ_012MH

Insp Date: **7/10/07 11:17 AM**

Location Address: **3501 WOODBROOK**

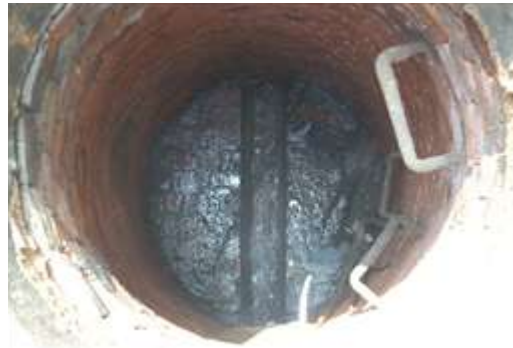
Top View

Debris on bench and channel

abandoned i9

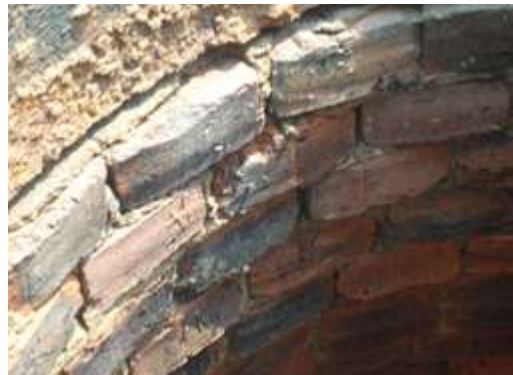
Defect 2

Condition: ☐ Sound ☐ Cracked ☐ Root Intrusion ☐ Loose Brick ☒ **Deteriorated**

deterioration of corbel

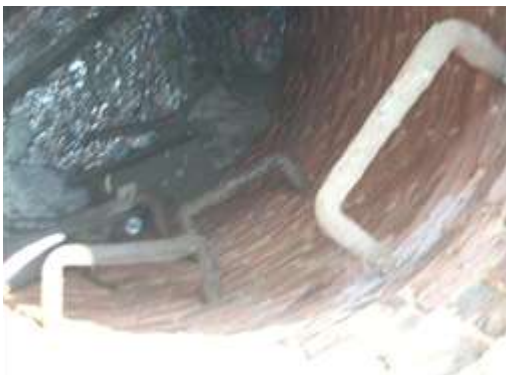
Defect 1

Steps Count: **5** Missing: **0** ☒ **Corroded**

coroded steps

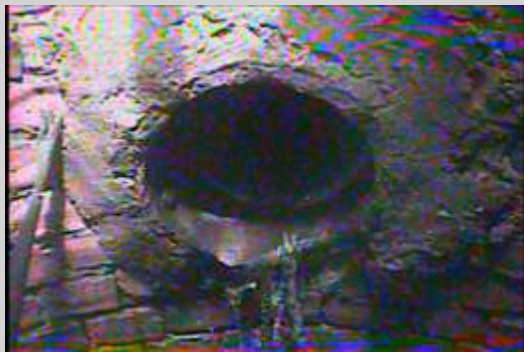
8 in. Circular Gravity Sewer
Pipe In @ 6 O'Clock

Pipe Height: **8.4** (in.) Rod and Bar (Angled)
Pipe Material: **Clay** ☐ Pipe Lined
Invert Depth: **9.47** (ft.) Flow Characteristics: **Slow**
Deposits: ☒ None ☐ Mud ☐ Sludge ☐ Debris ☐ Grease
Silt Depth: (in.) Deposits Extent:
Infiltration: **None** Pipe Seal Cond: **Sound**

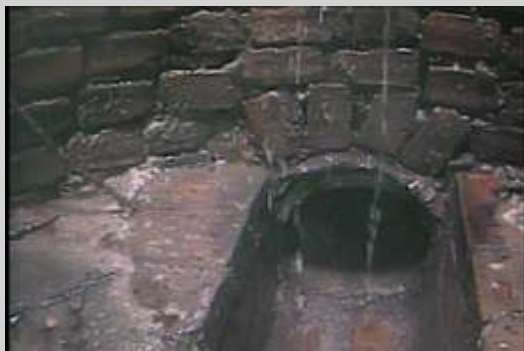
8 in. Circular Gravity Sewer
Drop In @ 6 O'Clock

Pipe Height: **8.4** (in.) Rod and Bar (Angled)
Pipe Material: **Clay** ☐ Pipe Lined
Invert Depth: **5.62** (ft.) Flow Characteristics: **Slow**
Deposits: ☒ None ☐ Mud ☐ Sludge ☐ Debris ☐ Grease
Silt Depth: (in.) Deposits Extent:
Infiltration: **None** Pipe Seal Cond: **Broken**

Drop: **Outside** Rod and Bar
Angled: **Yes** Reading: **8.31** (ft.)
Inv Depth: **9.31** (ft.)
Drop Condition: **Partly Clogged**
